TS-PIC- 90783/91783
November 1990

AERIAL PHOTOGRAPHIC ANALYSIS OF SHELL CHEMICAL - DEER PARK MANUFACTURING COMPLEX

Deer Park, Texas

EPA Region 6

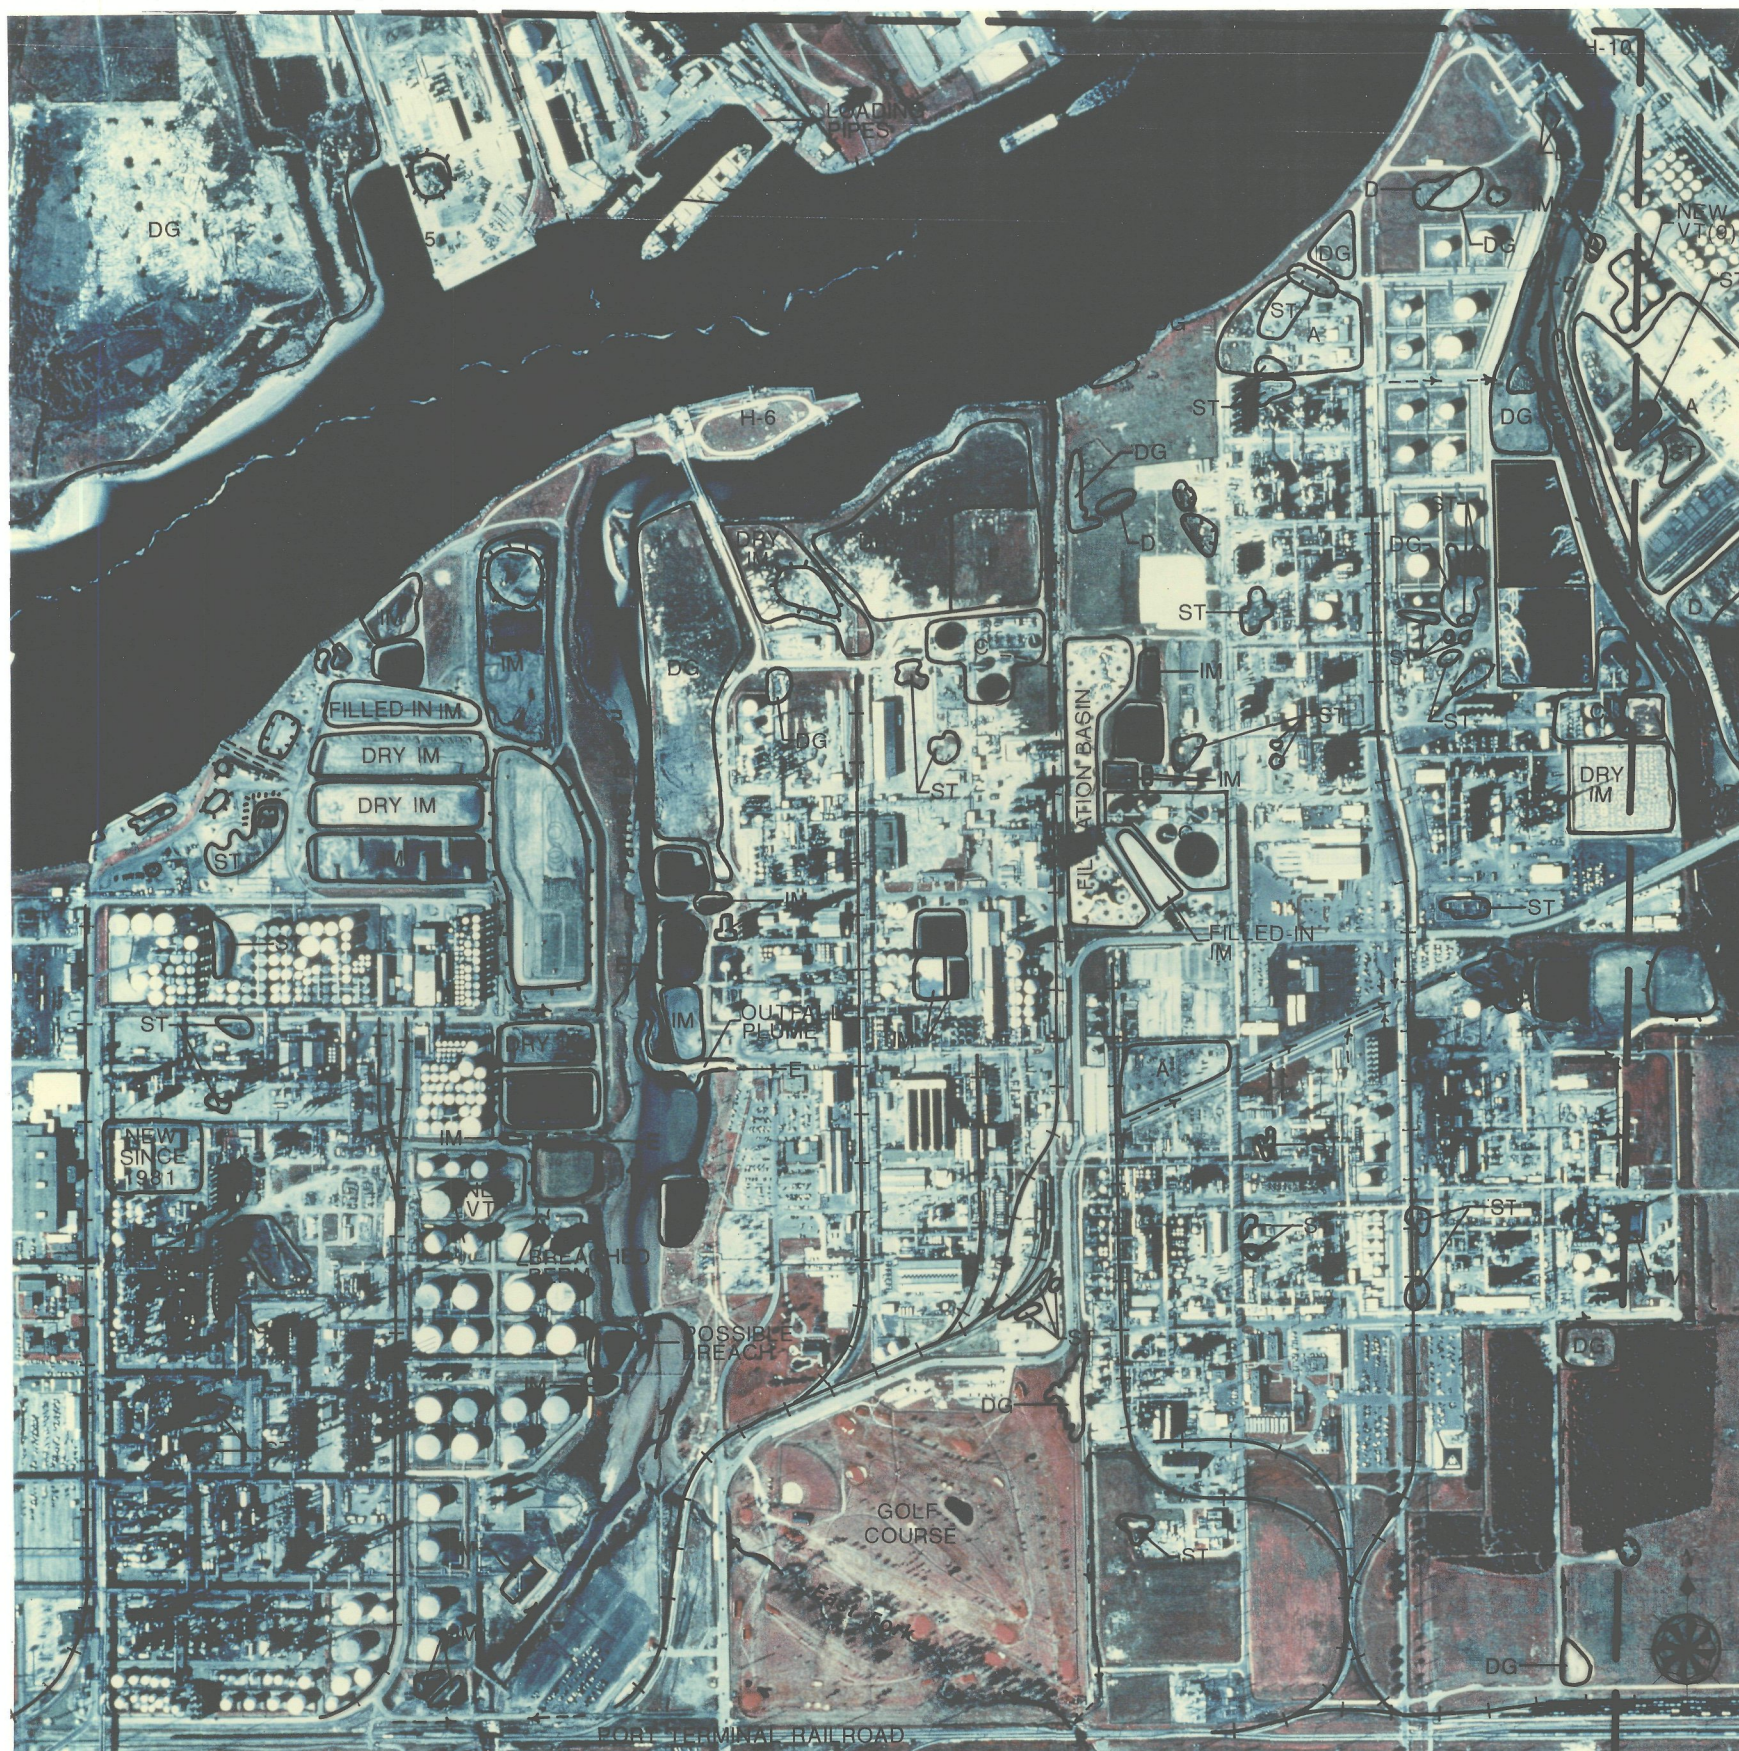
Figure 9. Shell Chemical-Deer Park Manufacturing Complex, March 9, 1989.
Approximate scale 1:10,800.

This photo covers the northeast quadrant of the study area. This photo roughly corresponds to Figure 5. The storage tanks appear to be adequately contained. Stains are visible in several areas of the facility. There are 32 liquid impoundments visible on this photo, as well as 12 areas of ground disturbances. There is a significant outfall plume visible in Patrick Bayou. Areas of mounded materials are also visible. The large area of mounded material on the west side of Patrick Bayou was being used in 1981 as a dumping area and has since been covered over with fill material. One impoundment that borders Patrick Bayou has been noted as possibly having a breached wall allowing its contents to flow into Patrick Bayou. A liquid impoundment has been filled in since 1981; it is located east of the filtration basins. Other significant features are described below.

Annotation	Description
A	These are three storage areas.
C	These are three water treatment facilities.
D	These are five areas where dumping has occurred.
E	These are seven areas where an outfall has been noted.
F	This is a waste disposal area.
H-4	This is a ship mooring.
H-5	This ship loading/unloading facility handles heavy material and equipment and containerized cargo.
H-6	This ship loading/unloading facility handles petrochemicals, chemicals, and heavy materials and equipment.
H-7	This ship loading/unloading facility handles bulk cement, molasses, fertilizer, and grain.
H-9	This ship loading/unloading facility handles steel and fabricated steel products.
H-10	This ship loading/unloading facility handles petrochemicals and chemicals.

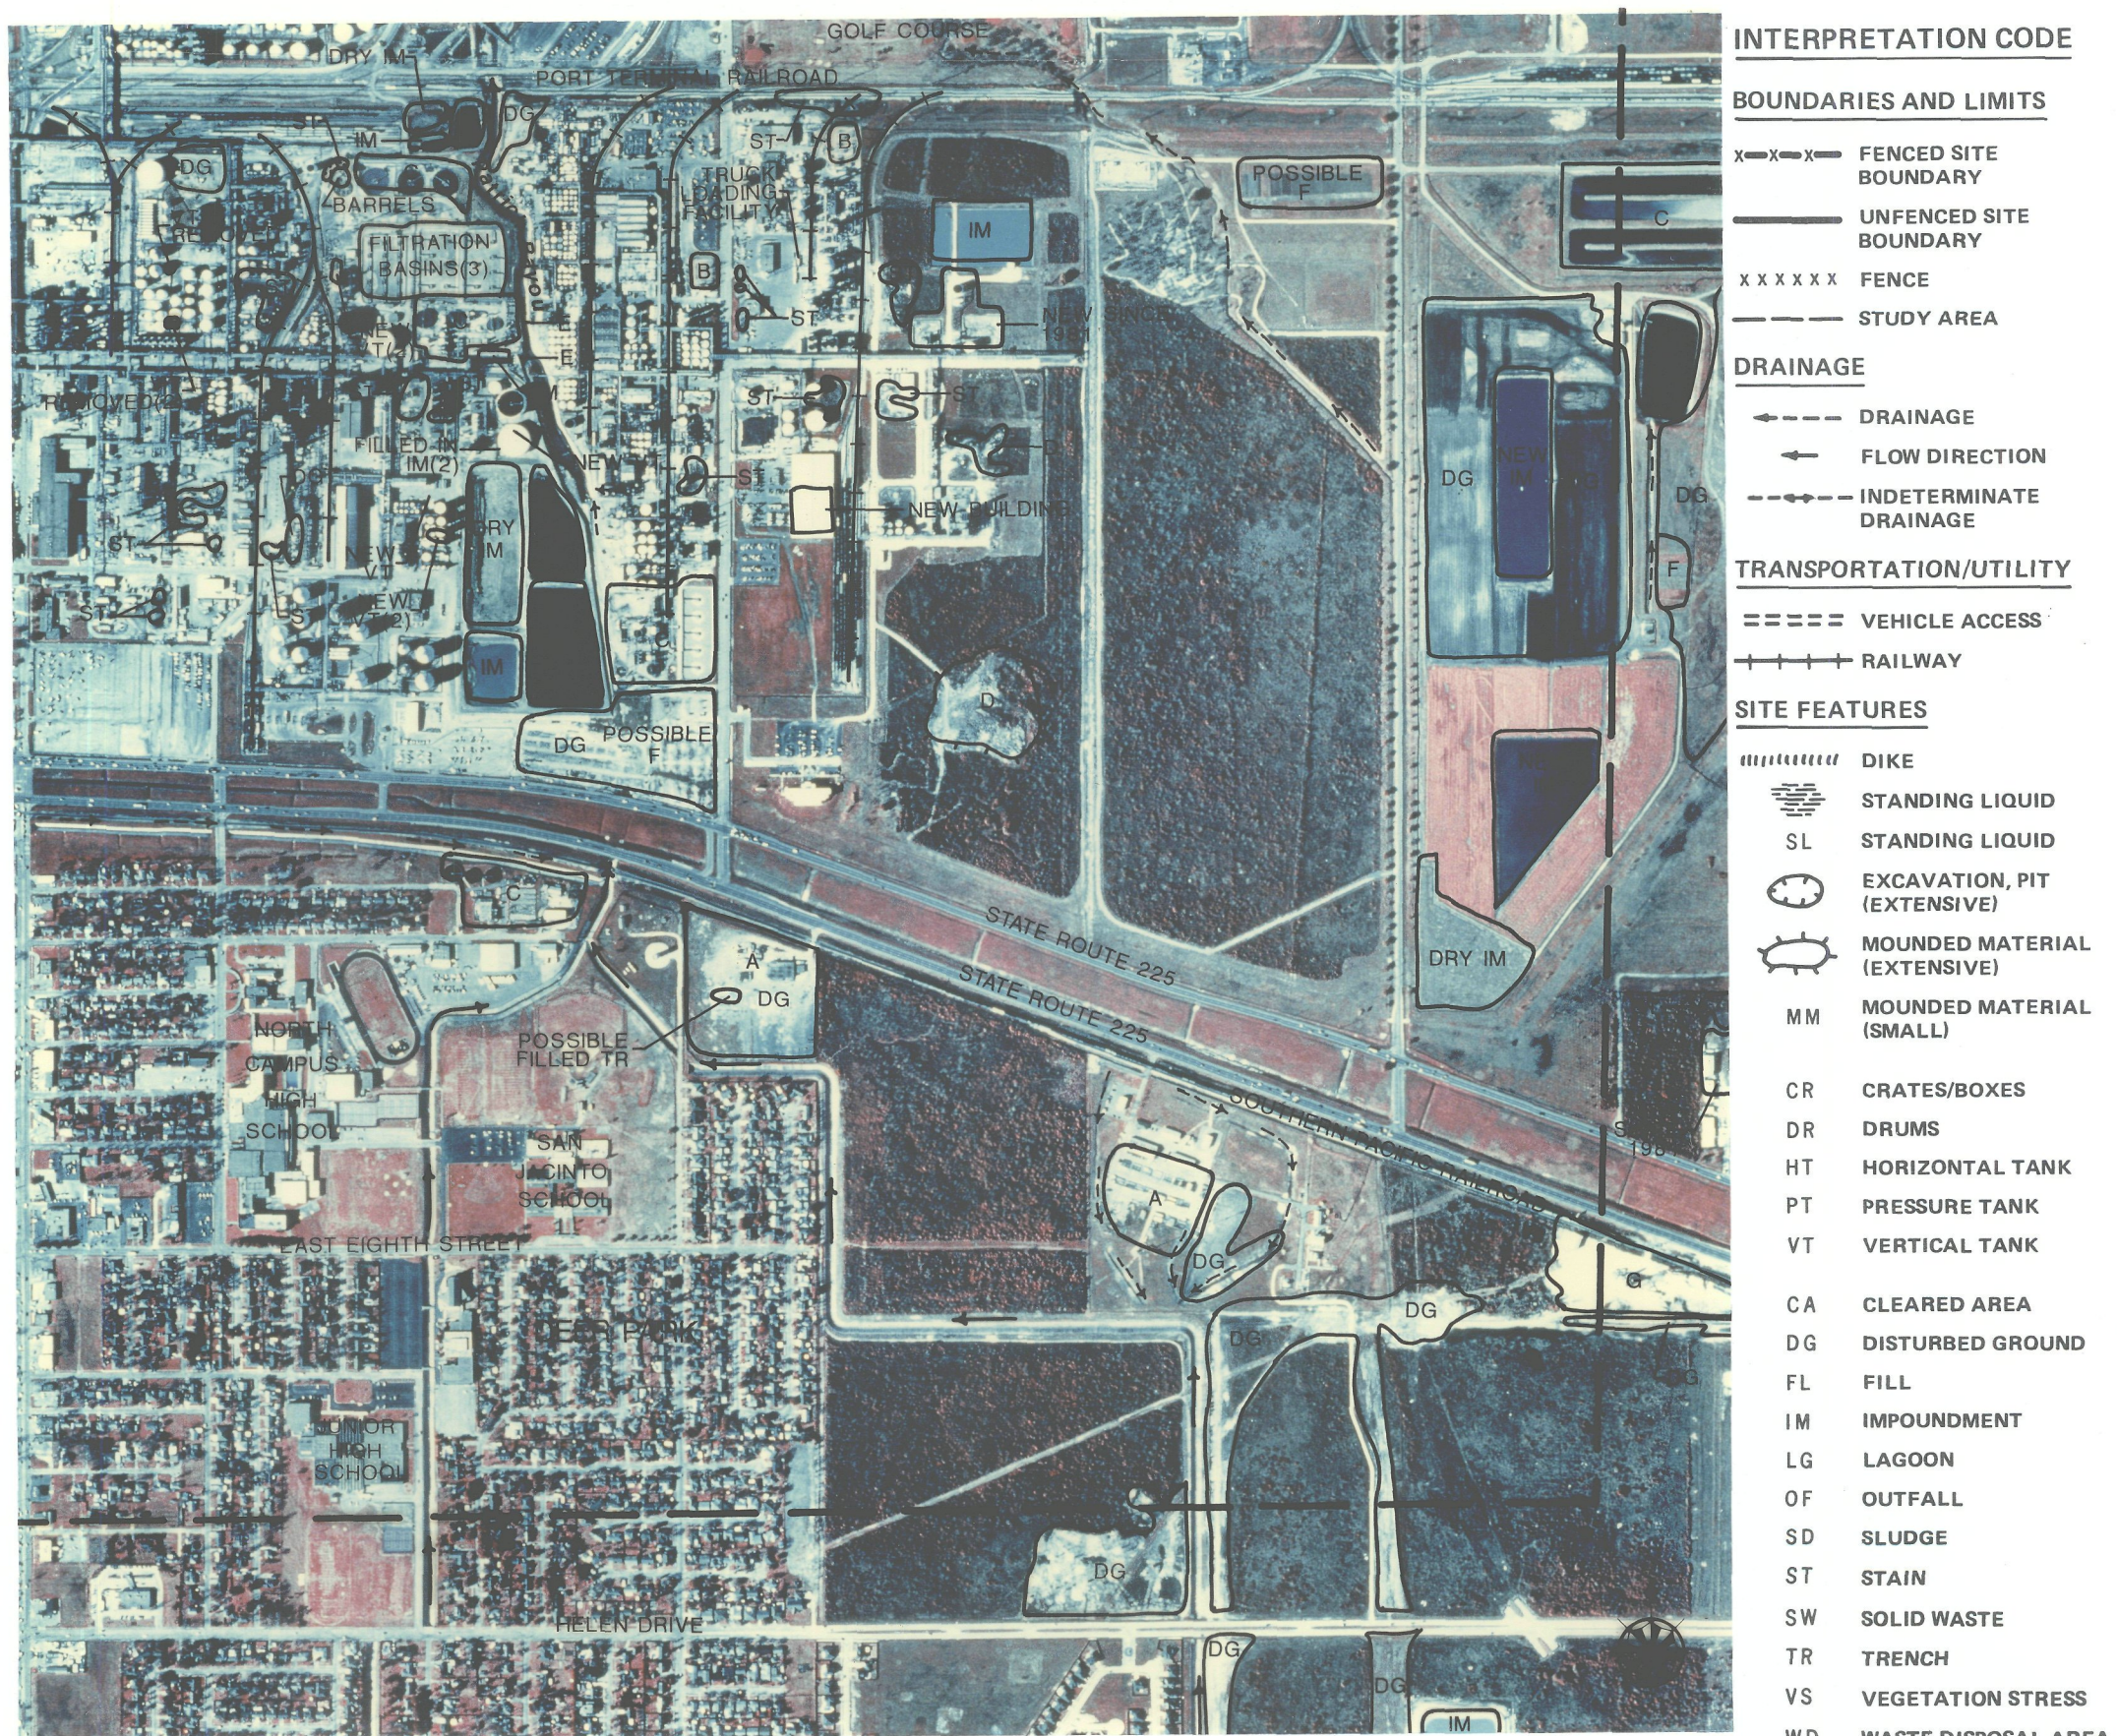
Figure 10. Shell Chemical-Deer Park Manufacturing Complex, March 9, 1989. Approximate scale 1:10,800.

This photo covers the southeast quadrant of the study area. It roughly corresponds to Figure 6. All the storage tanks in this photo are adequately contained. Staining is visible in several areas. There are 17 liquid impoundments, and 8 areas of ground disturbances visible. Three vertical storage tanks have been removed since 1981. Six vertical storage tanks have been added since 1981. An area that is storing barrels has been noted. A facility used for the loading of trucks has also been noted. The northern part of Deer Park is visible, and three schools were identified in the study area. Three areas that have had new construction since 1981 were noted. An area that had two impoundments in 1981 was filled in and a new vertical storage tank was built on that site. Other significant features are described below.

Annotation	Description
A	These are two storage areas that contain various construction material, and some staining. One has a possible filled trench.
B	These are power substations.
C	These are five water treatment facilities.
D	These are two areas where dumping is occurring.
E	There are two areas where there is an outfall source going into Patrick Bayou.
F	These are areas that are possibly being used as waste disposal areas.
G	This is a sand and gravel operation with a facility for loading and unloading railcars, and is supported by the Southern Pacific Railroad.

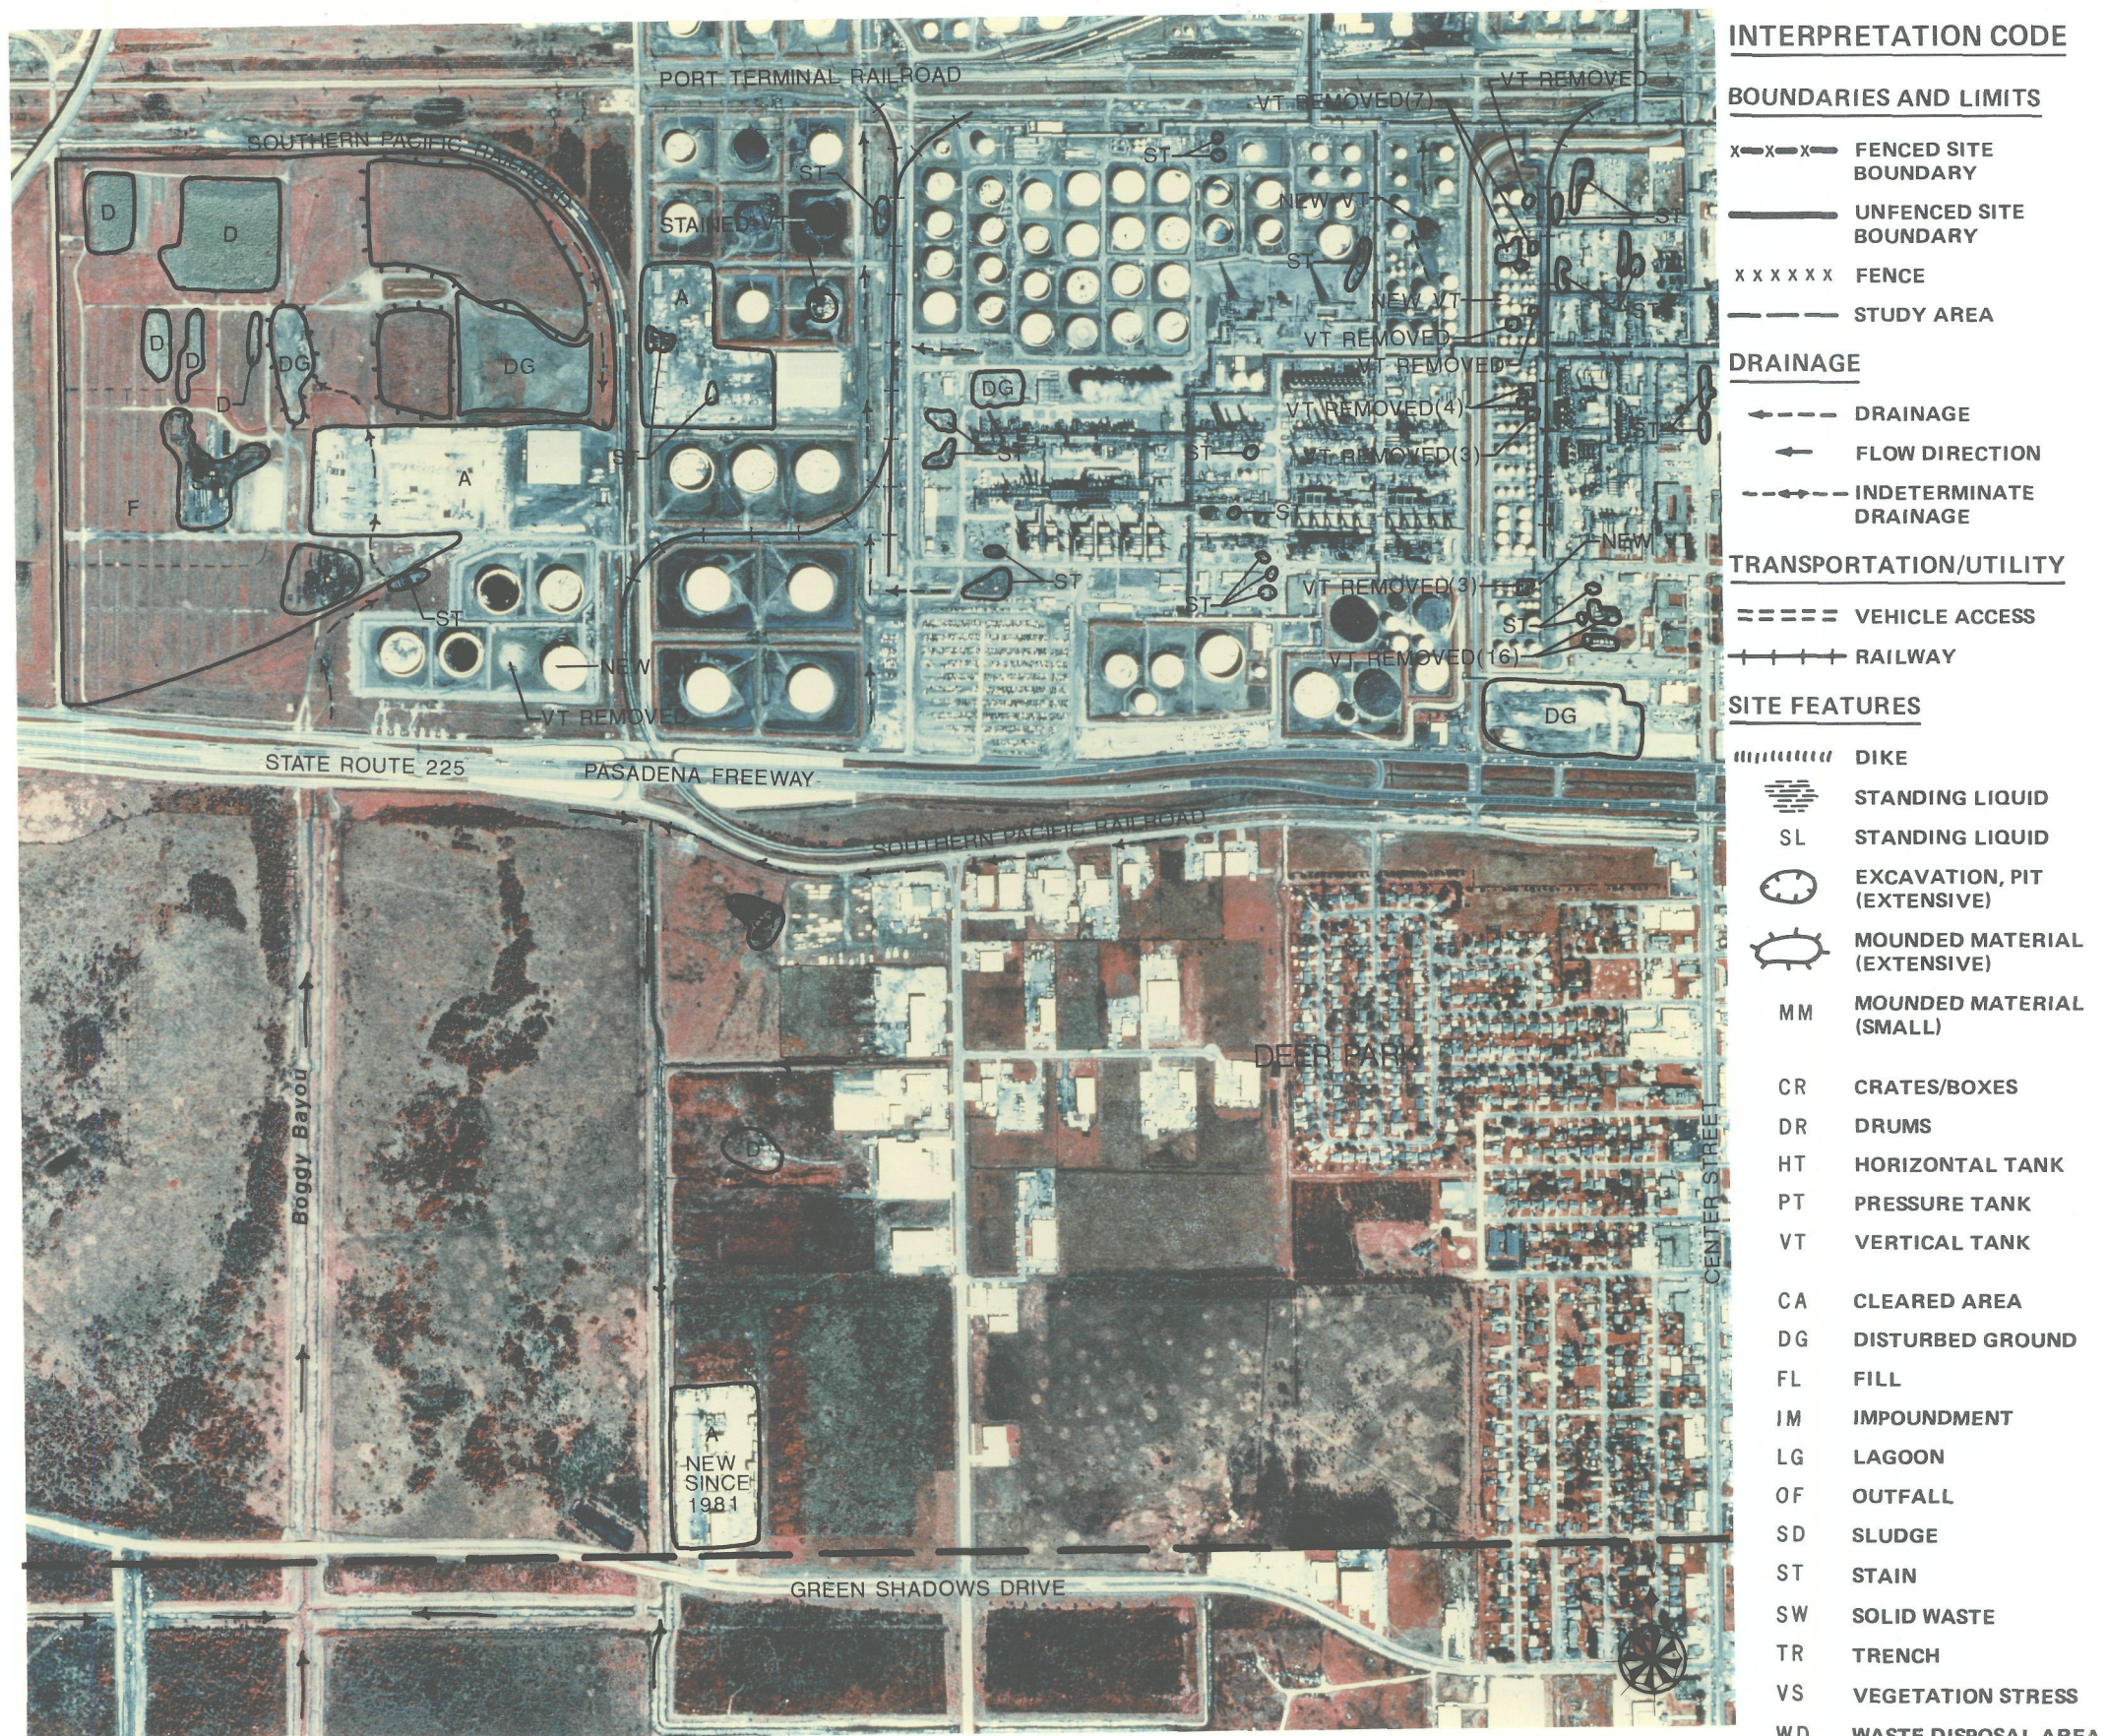
Figure 11. Shell Chemical-Deer Park Manufacturing Complex, March 23, 1989.
Approximate scale 1:10,800.

This photo covers the southwest portion of the study area, and roughly corresponds to Figure 7. The storage tanks in the photo all have adequate containment. Staining is visible in many areas. Three areas of ground disturbances have been noted and no liquid impoundments were identified. In the area marked as the waste disposal area significant dumping is noted. The trenches visible in 1981 are mostly filled in and starting to be covered over. Large mounds of possible waste material are also visible in the waste disposal area. Other significant features are described below.

Annotation	Description
A	These are three storage areas.
D	Dumping has occurred in these six areas.
F	This is a waste disposal area, and was described above.

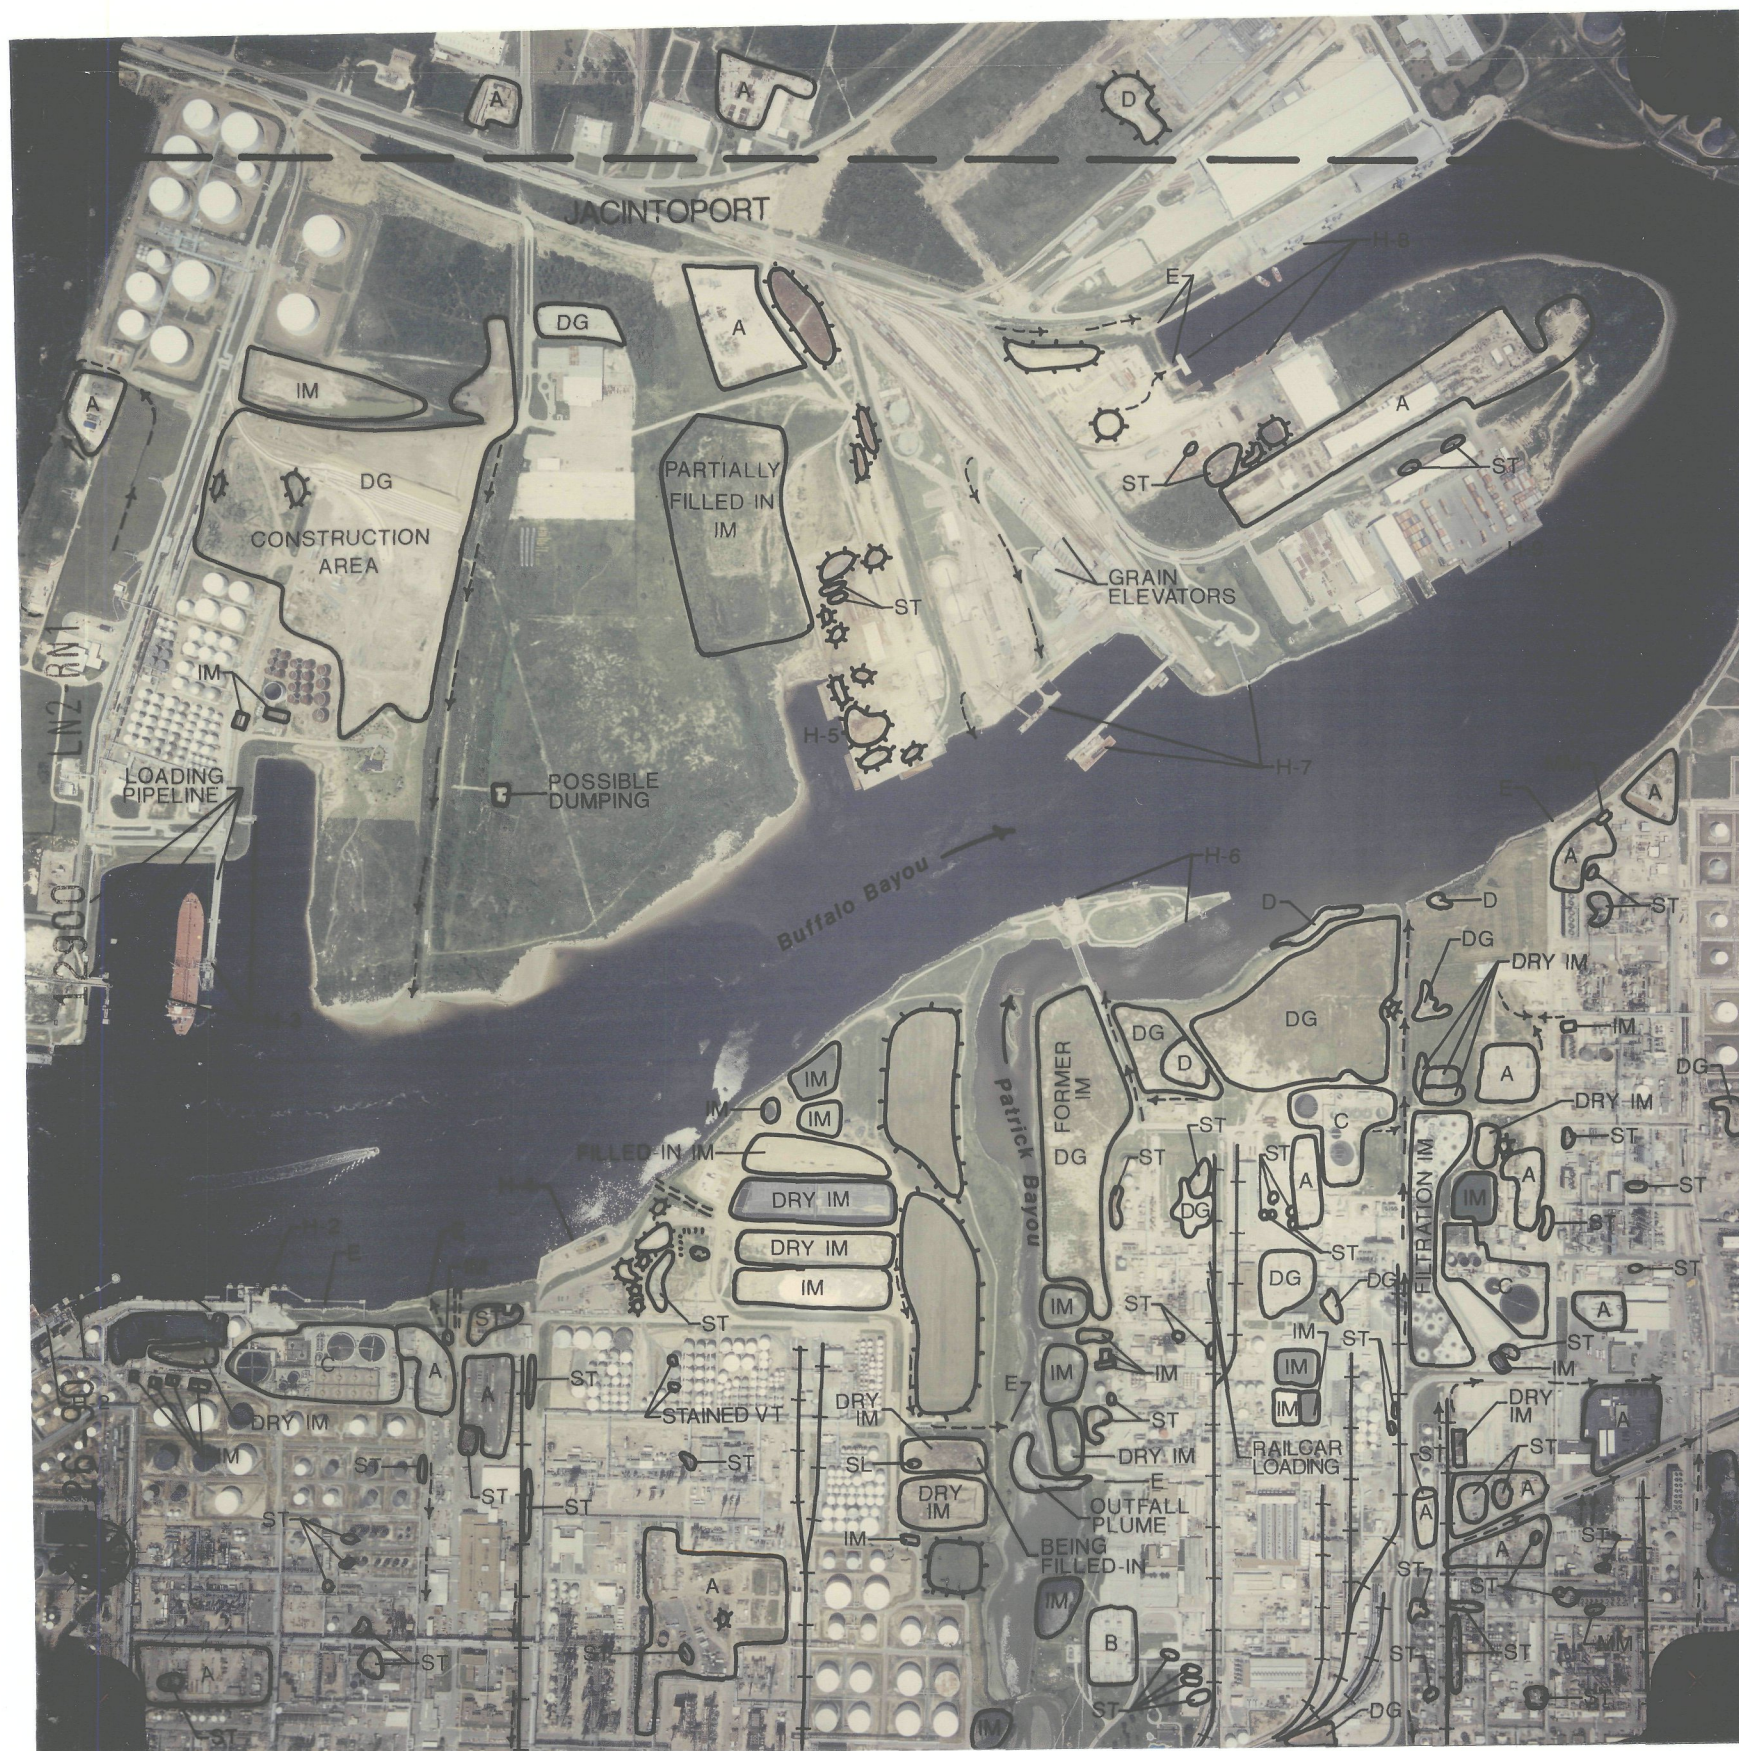
Figure 12. Shell Chemical-Deer Park Manufacturing Complex, August 26, 1990. Approximate scale 1:12,900.

This photo covers an area covered in Figures 5 and 9. The storage tanks in this area are adequately contained. Areas of stains are visible throughout the facility. A significant outfall plume is visible in Patrick Bayou. This plume was also visible in the previous years of photography. There are several areas of mounded material in various locations. Most of these mounds appear to be associated with a rail or a port facility. Two impoundments are filled in or are being filled in on this photo. Nine areas of ground disturbances have been noted, as well as 32 liquid impoundments. Other significant features are described below.

Annotation	Description
A	These are 16 storage areas, with a wide variety of materials and equipment, and in many of these areas there are large stains.
B	This is a power substation.
C	These are two water treatment facilities.
D	These are four areas where dumping has been occurring.
E	Seven points of discharge are noted on the photo.
H-2	This ship loading/unloading facility handles petroleum coke, crude oil, petroleum products, and chemicals.
H-3	This ship loading/unloading facility handles petroleum coke, crude oil, petroleum products, vegetable oil, tallow, animal fats, sand, gravel, stone, cement, phosphate rock, and aragonite.
H-4	This is used for the mooring of towboats.
H-5	This ship loading/unloading facility handles heavy material and equipment, and containerized cargo.
H-6	This ship loading/unloading facility handles petrochemicals, chemicals, heavy material, and equipment.
H-7	This ship loading/unloading facility handles grain, molasses, and fertilizer.

H-8	This ship loading/unloading facility handles steel and fabricated steel products.
H-9	This ship loading/unloading facility handles steel and fabricated steel products.

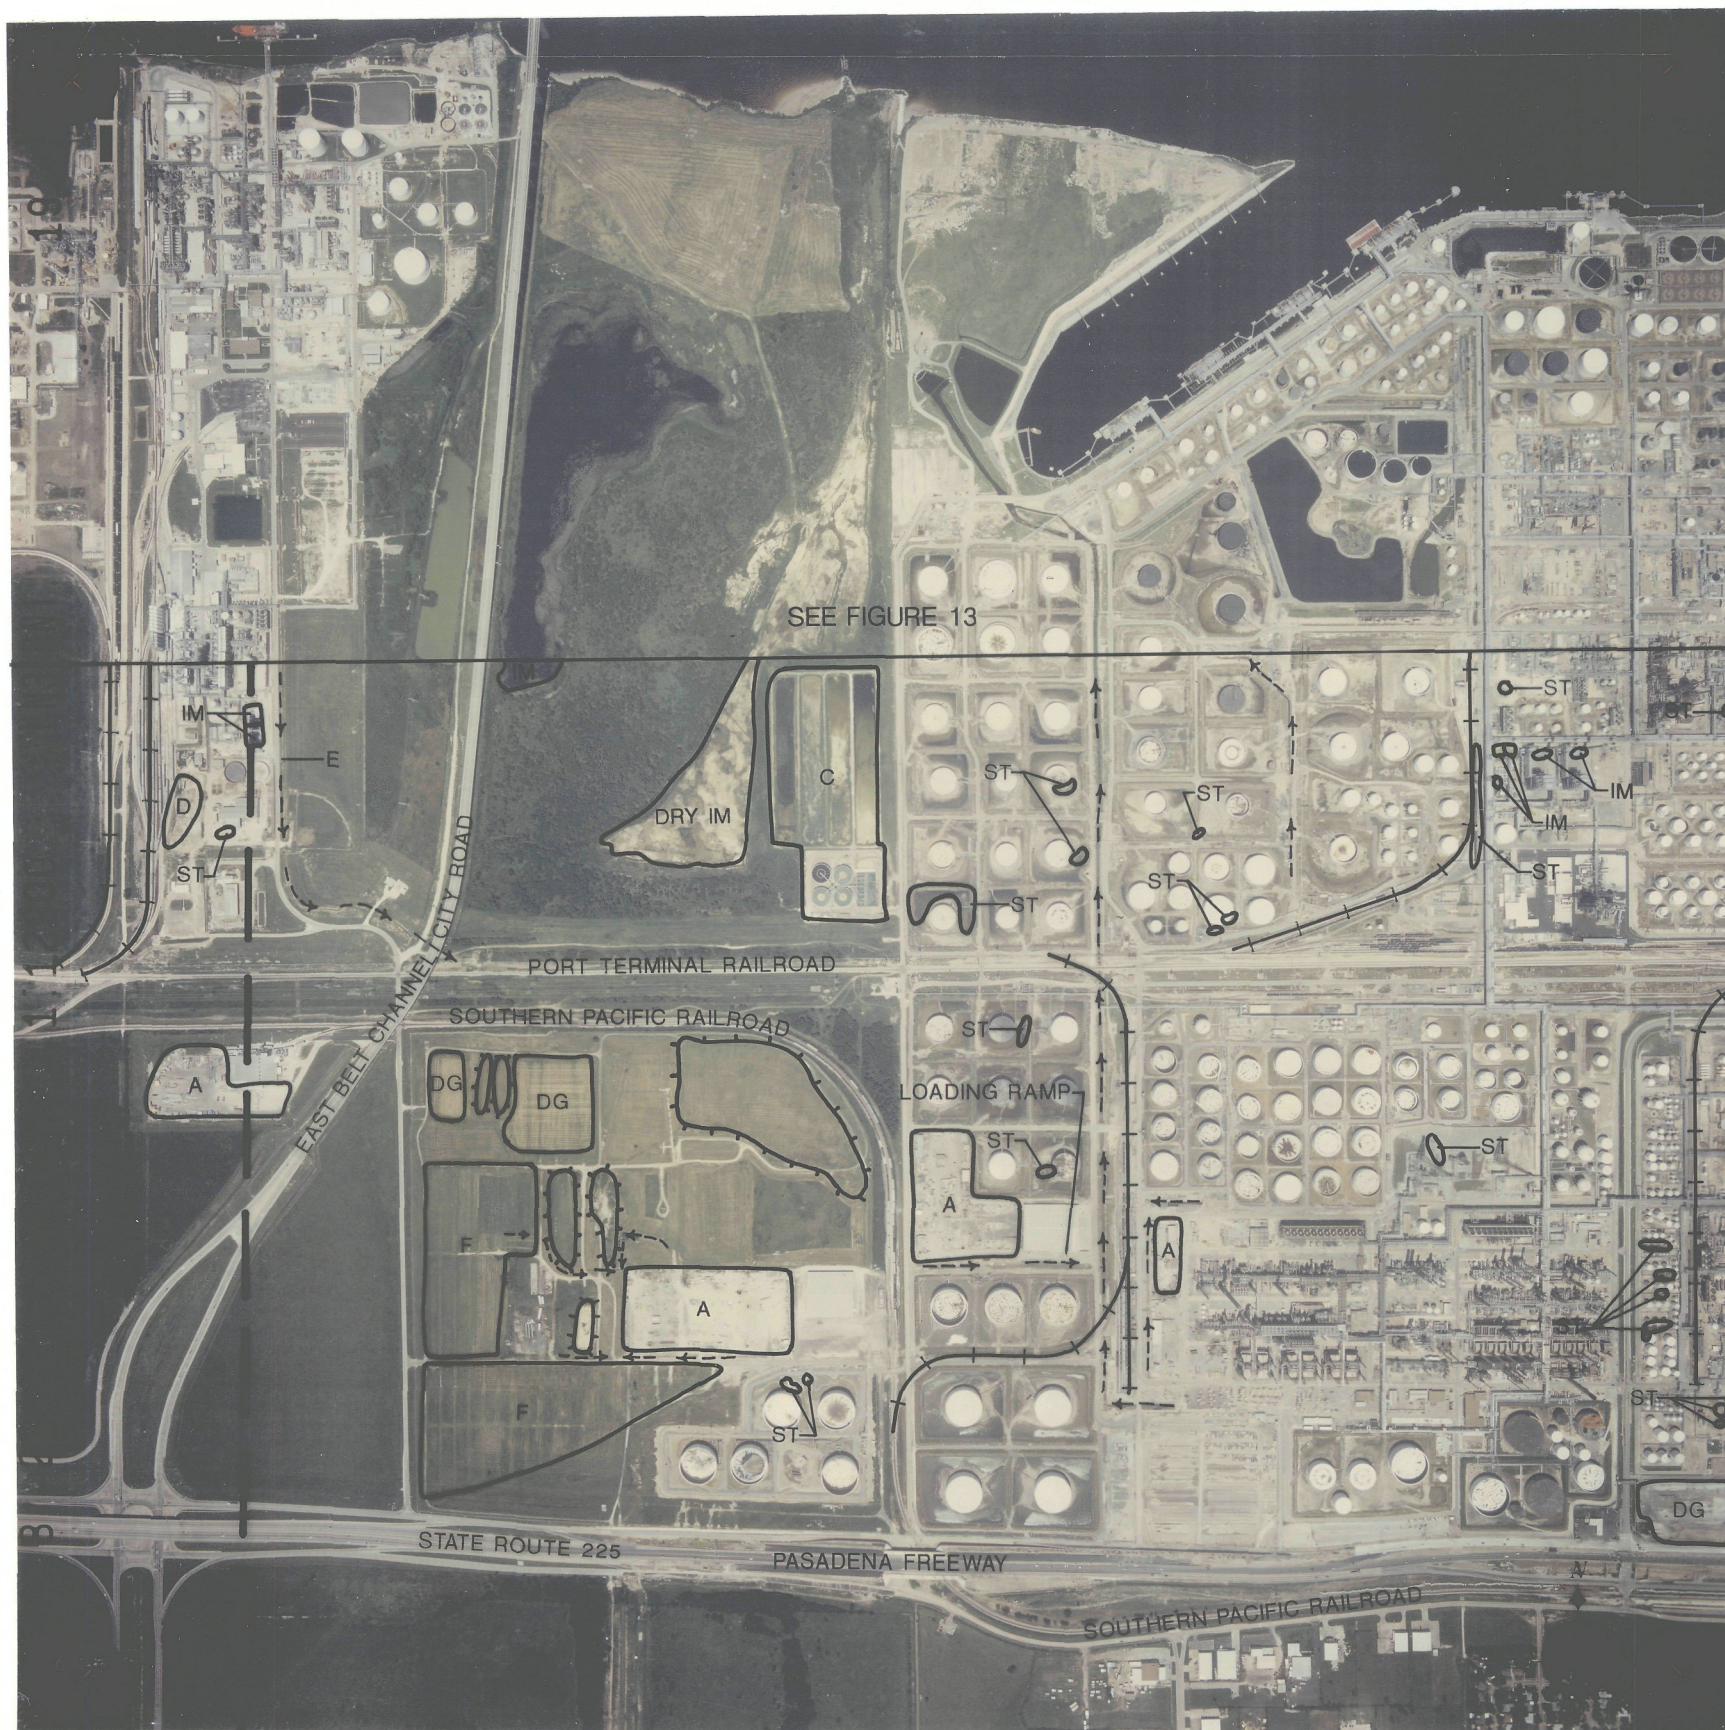
Figure 14. Shell Chemical-Deer Park Manufacturing Complex, August 26, 1990.
Approximate scale 1:12,900.

This photo covers an area that was previously looked at in earlier photography covered in Figures 4, 5, 8, and 11. All the storage tanks in this photo are adequately contained. There is staining visible in many areas. Nine liquid impoundments and 3 areas of ground disturbances are visible. Near the waste disposal area are several large mounds of possibly waste material. The trenches that were visible in the previous years have for the most part been filled in and covered over. In the 1989 photography extensive areas of dumping were seen in this area. Since then the material that had been dumped there has been removed, leaving only ground scars. Other significant features are listed below.

| A | These are four storage areas. |
| C | This is a water treatment facility. |
| D | This area has been used for dumping. |
| E | This is a discharge pipe going into a small drainage. |
| F | These are two waste disposal areas. |

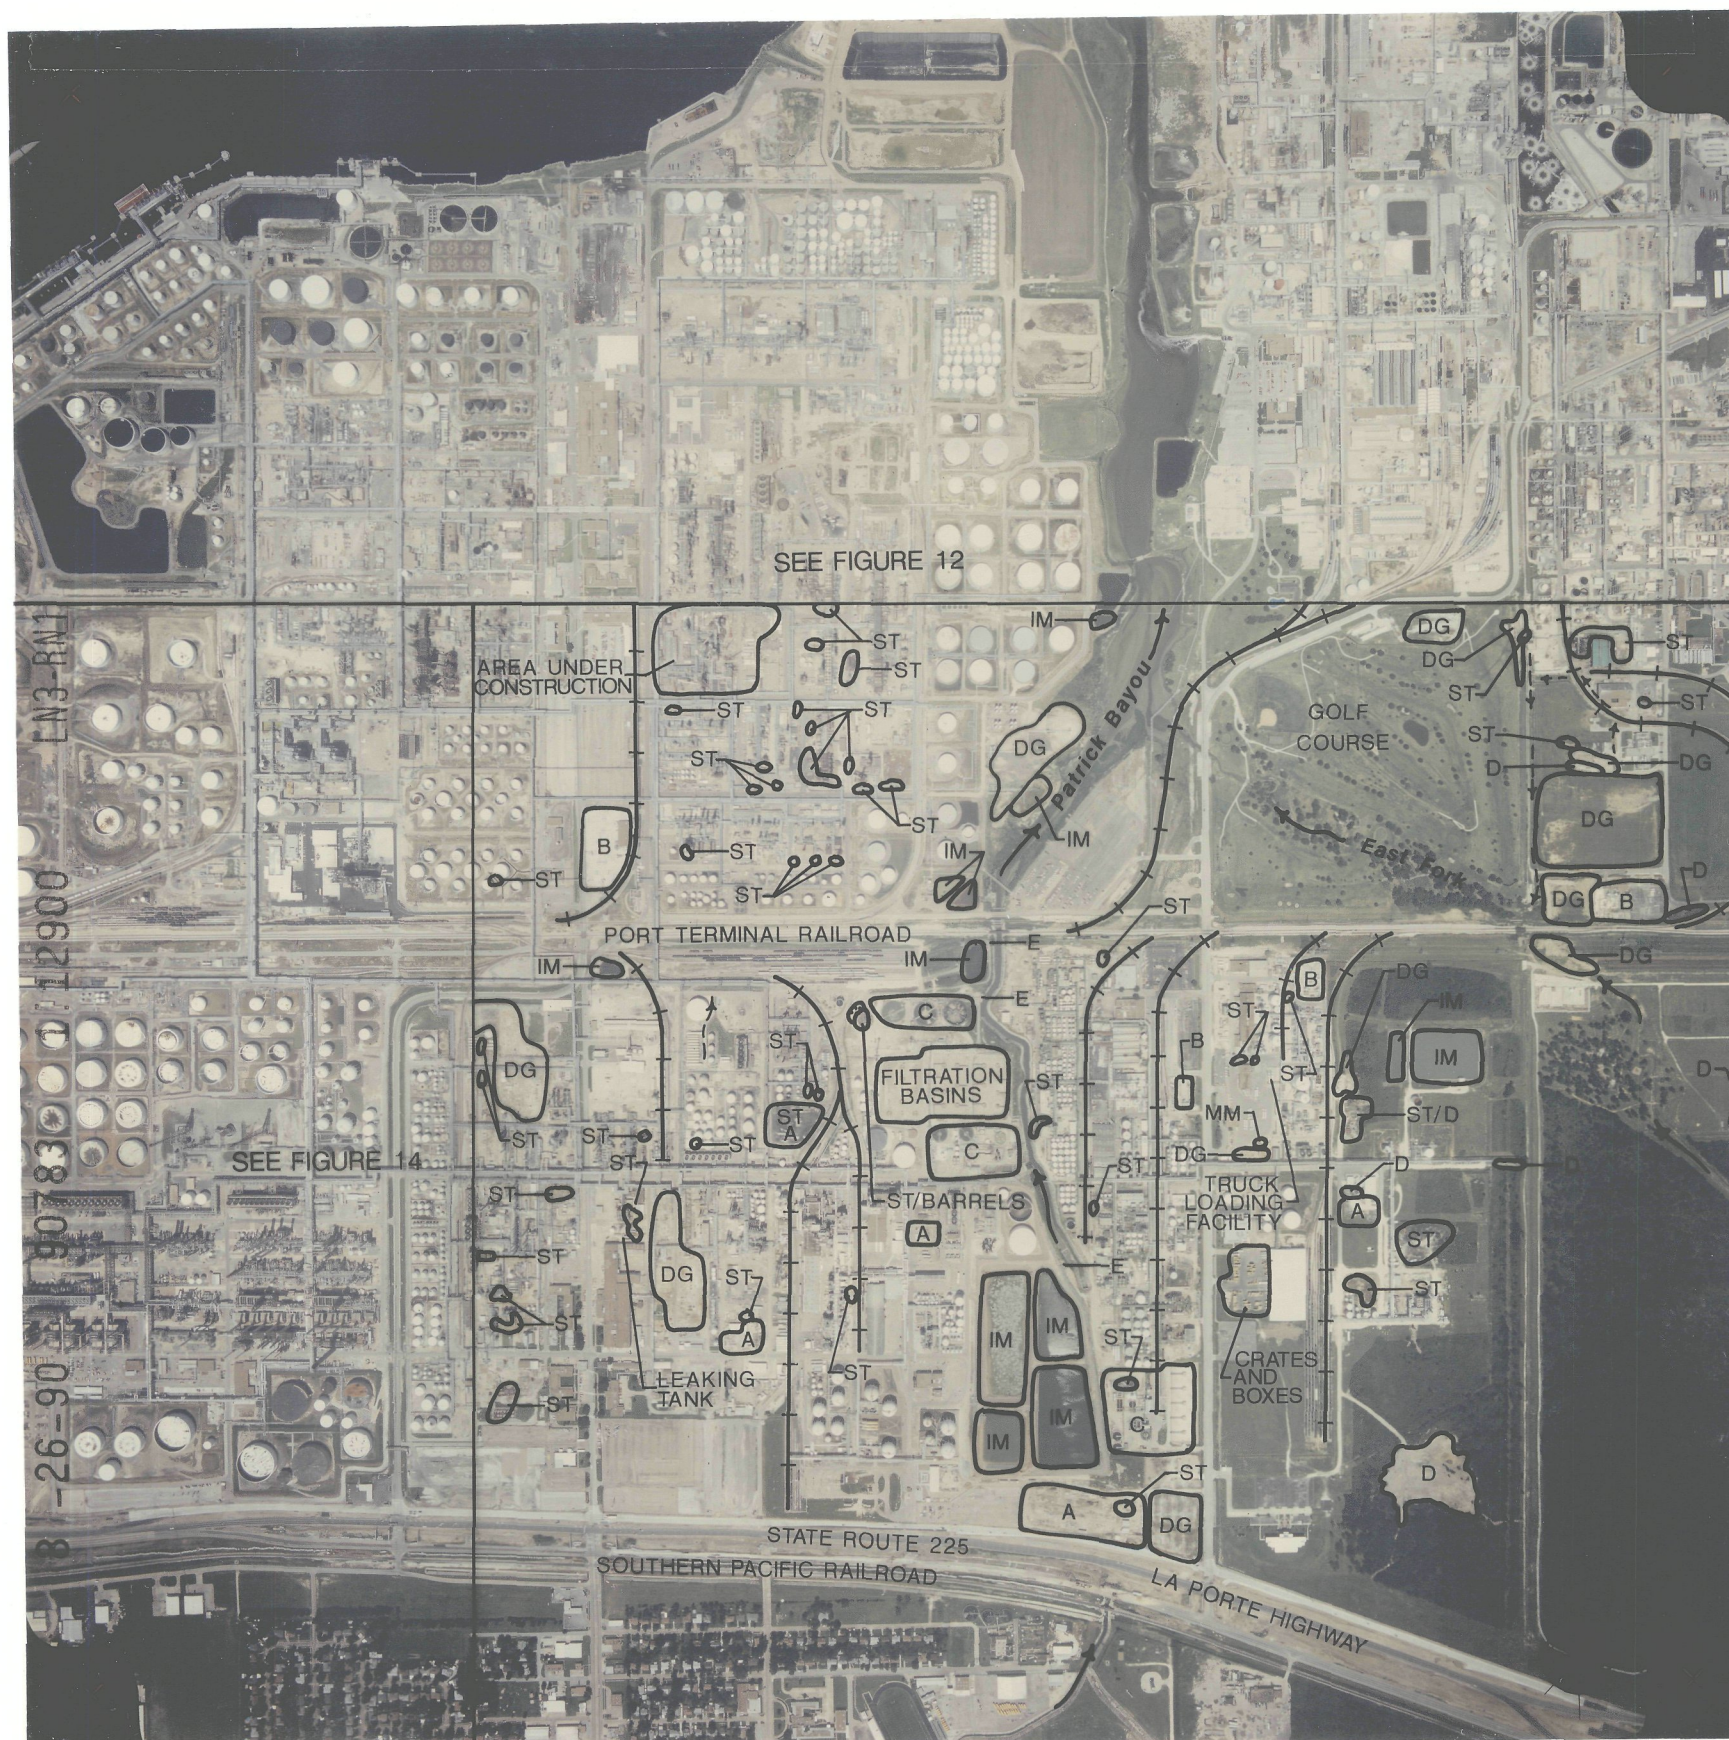
Figure 15. Shell Chemical-Deer Park Manufacturing Complex, August 26, 1990. Approximate scale 1:12,900.

This photo covers areas that were discussed earlier in Figures 5, 6, 9, and 10. All the storage tanks in this photo are adequately contained. Staining is visible in many areas. There are a significant amount of barrels being stored in one location marked on the photo. Some staining is visible with the barrels. Eleven liquid impoundments and 12 areas of ground disturbances have been noted. A small horizontal storage tank has been noted as leaking. There is some ground staining as a result of this. Other significant features are described below.

Annotation	Description
A	These are five storage areas.
B	These are four power substations.
C	These are three water treatment facilities.
D	These seven areas have been used for dumping.
E	These are three areas of liquid outfall into Patrick Bayou.
